# High Reliability Lead-free Solder SN100C (Sn-0.7Cu-0.05Ni+Ge)

Nihon Superior Co., Ltd.  
Overseas Business Development Dept.  
Satoshi Mizuta

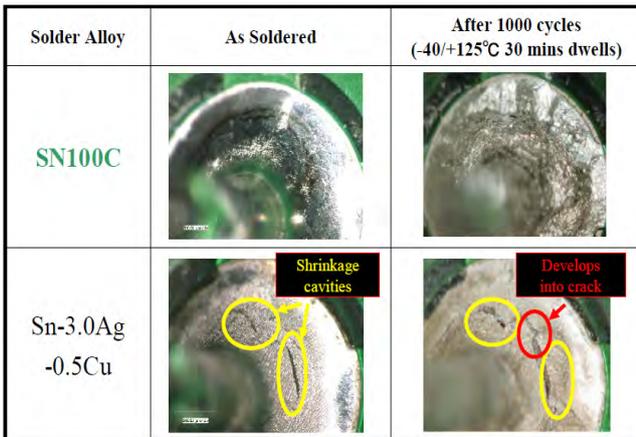
Figure1 Examples of shrinkage effects

Figure 1 shows SN100C and SAC305 joints in the as soldered condition (right) and after 1000 thermal cycles (-40/+125°C, 30 minute dwells).

In the case of the SN100C, because it solidifies nearly isothermally as a eutectic at 227°C there is no shrinkage cavities and the surface is smooth and bright. After thermal cycling the surface of the SN100C is disturbed by slip bands but there is no evidence of cracking. By contrast shrinkage cavities are apparent in the as-soldered SAC305 and after thermal cycling cracks have developed from these cavities. Here we will explain the mechanism of

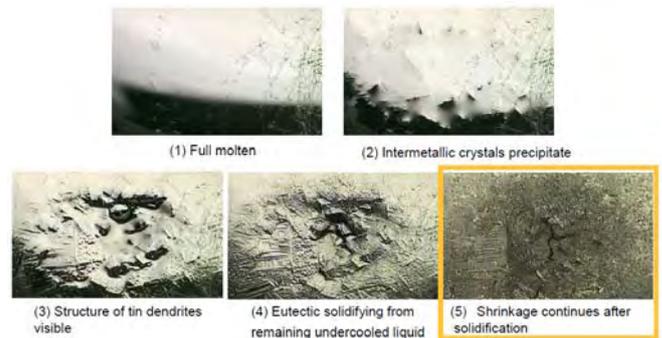
The way in which shrinkage cavities form can be explained by reference to Figure 2. Solidification begins with the growth of primary tin dendrites in areas where the temperature of the molten solder has fallen below the liquidus (2). These tin dendrites continue to grow (3) until the remaining liquid starts to freeze as a eutectic, shrinking away from the network for dendrites to leave cavities (4). As the now solid solder cools it continues to contract further opening up the shrinkage cavities (5)

Figure 2 Mechanism of Shrinkage Occurrence

shrinkage occurrence (Figure 2).

In addition, it is important to refine intermetallic and solidify at a stretch by selecting an eutectic solder whose solidus and liquidus temperature is same in order to reduce shrinkage. Since SN100C is nearly eutectic almost no shrinkage occurs.

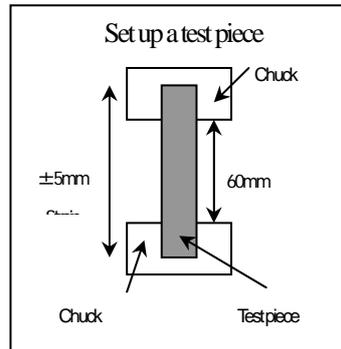
3. Tensile tester set up and test method (see Figure 4).

Clamp the test piece in the tester with a distance of 60mm between chucks.

Strain rate: 20mm/minute

Strain: ±5mm

Figure 4 Set up a test piece

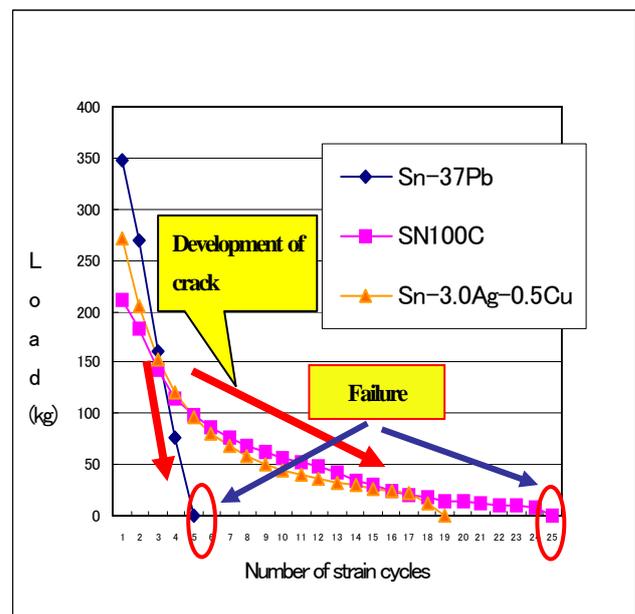
Figure 5 Peak stress at point of strain reversal

Figure 5 shows the peak stress at each cycle with the number of cycles to failure noted. The load required to achieve the specified strain decreases with each cycle because of the reduction in the effective test piece cross-section due to necking and crack propagation.

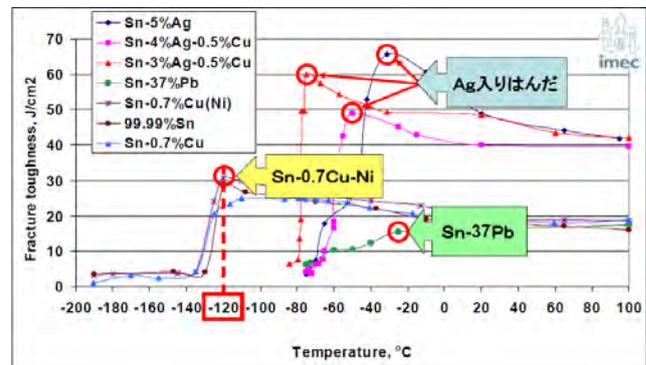
Figure 8 Reference: Ratchev et al., A Study of Brittle to Ductile Transition Temperatures in Bulk Pb-Free Solders, EMPC 2005 (IMAPs-Europe) June 12-15, Brugge, Belgium.

The results of Charpy impact tests conducted by a Belgian research laboratory are shown in Figure 8. In the Charpy impact test the energy per unit of cross-sectional area required for a swinging hammer (Figure 9) to fracture a test piece is used as a measure of the property of fracture toughness. In general the smaller the impact energy the more brittle is the alloy. The results indicate that SN100C has excellent resistance to impact at temperatures as low as -120°C.

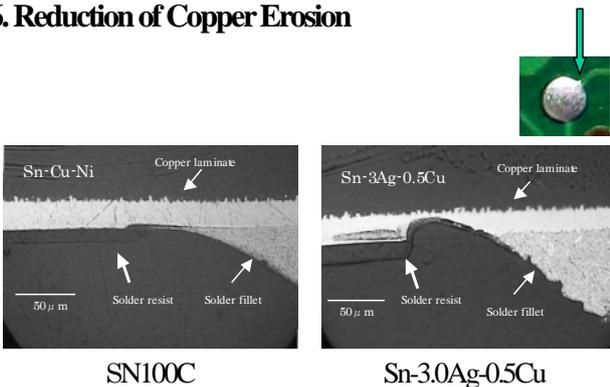
Figure 11. Copper erosion in single-sided board

Figure 11 shows the results of a copper erosion study carried out on single-sided boards. It can be seen that the copper of the trace connecting to the land has been almost completely eroded. The effect of the solder wave is apparent in that area. SN100C erodes copper more slowly than Sn-3.0Ag-0.5Cu.

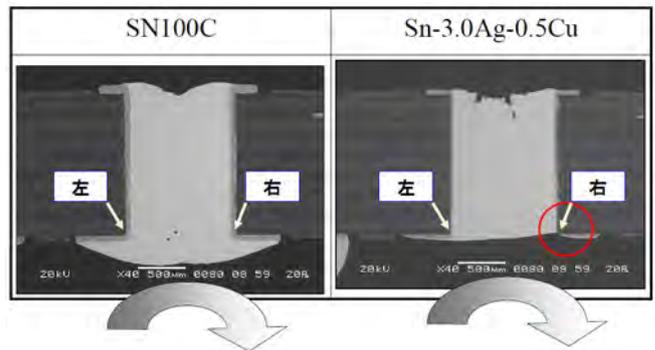
Figure 12 Erosion of the shoulder of a plated through hole on double sided board

The arrow in Figure 12 indicates the direction of solder flow. Since it was found that there is a difference in the extent of erosion between the right and left sides the thickness of the remaining copper was measured separately on each side. The results are plotted in Figure 13.

Erosion by the Sn-3.0Ag-0.5Cu is substantial and increases with immersion time. After 20 seconds the copper on the right side of the hole exposed to Sn-3.0Ag-0.5Cu has eroded completely while for the hole exposed to SN100C for the same time 81.6% of the original thickness of copper remains in that location. It is clear that SN100C erodes copper more slowly even at high temperature.

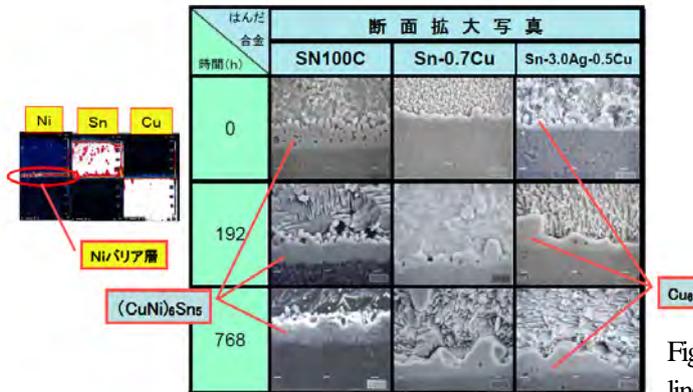
Figure14 Magnified cross section (Aging test at the high temperature)

Figure 14 shows the changes that occur in the intermetallic compound layer formed at the interface between a copper substrate and Sn-0.7Cu and Sn-3.0Ag-0.5Cu as a function of time at 120°C.

The Ni in the SN100C stabilizes the intermetallic so that it does not grow even during extended storage at high temperature (768 hours at 120°C). By contrast there is substantial growth in the intermetallic in the Sn-3.0Ag-0.5Cu alloy.

Although the intermetallic layer initially formed in the Sn-0.7Cu and the Sn-3.0Ag-0.5Cu is thinner than that formed in the SN100C, after long term aging at 120°C it has grown to a thickness greater than that of the SN100C. A thick layer of brittle interfacial intermetallic provides an easy pathway for crack propagation so that the reliability of the solder joint is compromised.

The trace addition of Ni in the SN100C incorporates in the interfacial intermetallic stabilizing it against further growth.

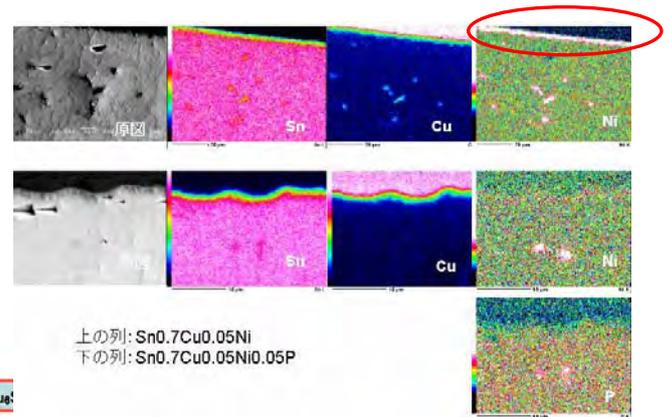
Figure15 SEM mapping (Upper line: Sn0.7Cu0.05Ni, Lower line: Sn0.7Cu0.05Ni0.05P)

The element mapping of solder joint cross-sections in Figure 15 shows where the Sn, Cu and Ni are concentrated. When P is added to the solder as an antioxidant the Ni is dispersed throughout the joint rather than concentrating in the interfacial intermetallic so the benefit of its stabilizing effect on intermetallic growth is not obtained.
